**(CAVITATION DAMAGE OF MECHANICAL  
PUMP IMPELLERS OPERATING IN  
LIQUID METAL SPACE POWER LOOPS)**

CAVITATION DAMAGE OF MECHANICAL PUMP IMPELLERS  
OPERATING IN LIQUID METAL SPACE POWER LOOPS

By R. S. Kulp and J. V. Altieri

Prepared under Contract No. NAS 3-2541 by  
PRATT & WHITNEY AIRCRAFT DIVISION  
UNITED AIRCRAFT CORPORATION  
CANEL - Middletown, Conn.

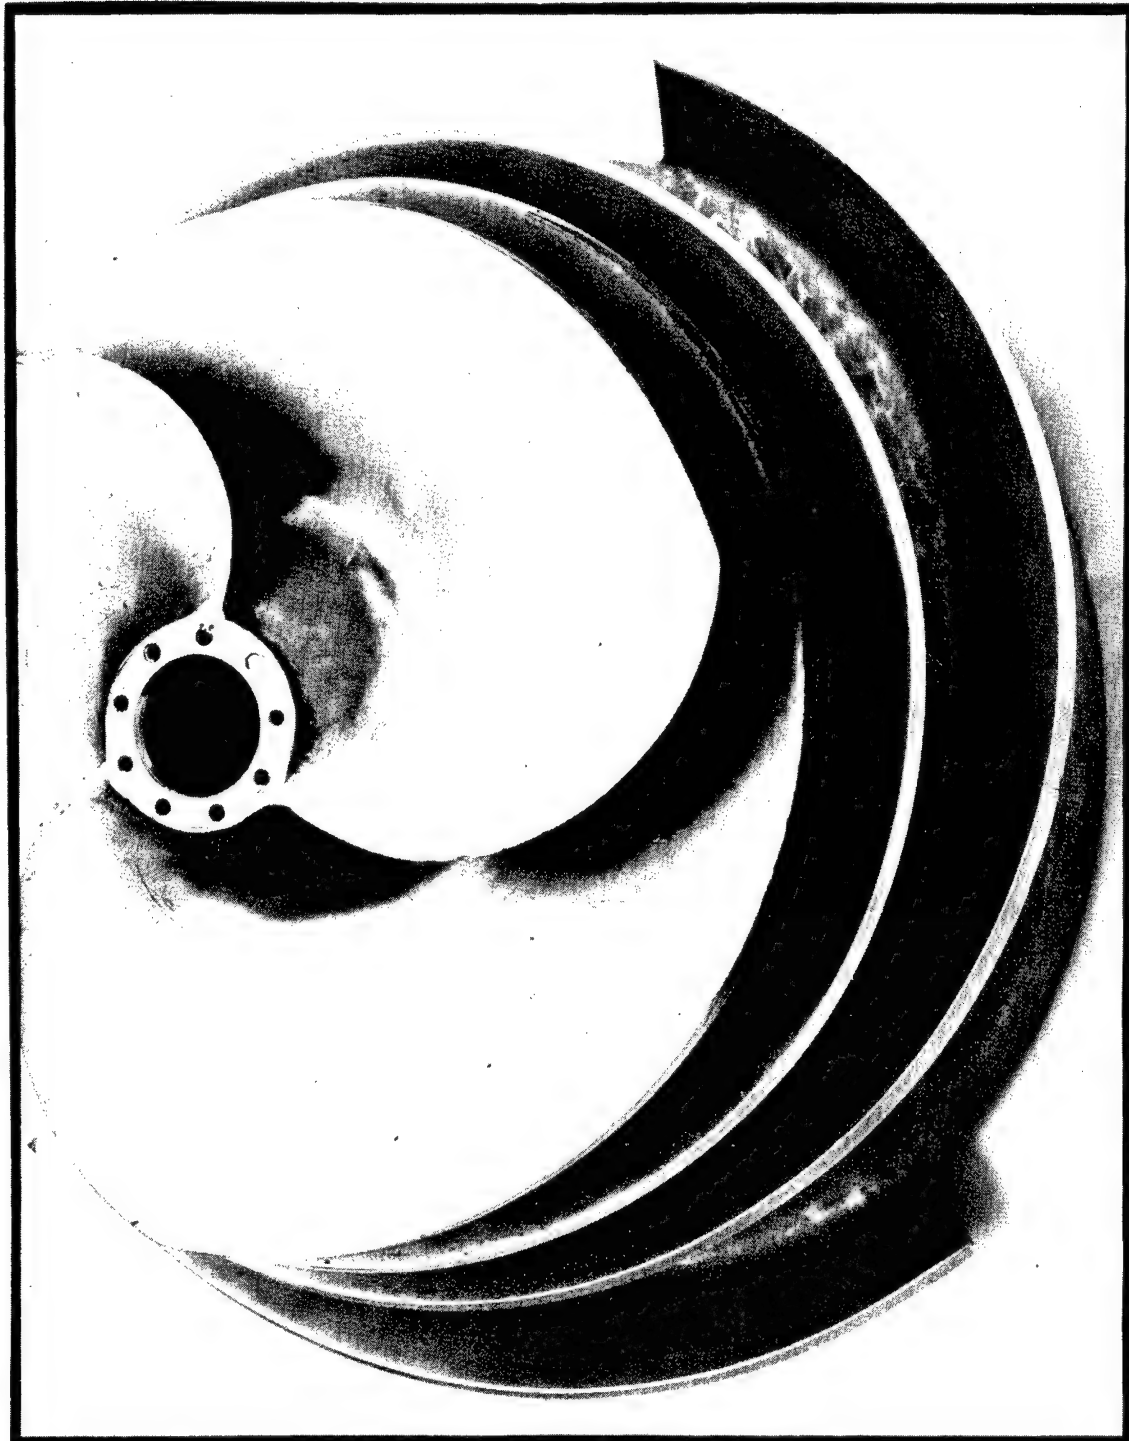
FIG 41

Upon completion of the pump tests and orifice calibrations, the turbopump was removed for disassembly and inspection. Visual inspection of the RI-7C3 impeller revealed scoring marks on the impeller (Fig. 41) and scroll insert (Fig. 42) where the two had contacted during the test. Analysis of the probable cause of rubbing contact led to the conclusion that it was caused by synchronous transients of vibration set up in the pump during tests of the 1.97 inches diameter orifice which cavitared violently. (The accuracy of this analysis is questionable in light of the liquid metal test results described in Section VIII.) The score marks were smoothed off, but not entirely eliminated before reassembly of the turbopump for the liquid metal test.

OVER-ALL VIEW OF LOCALIZED SCORING ON IMPELLER  
AFTER WATER TEST IN TURBOPUMP

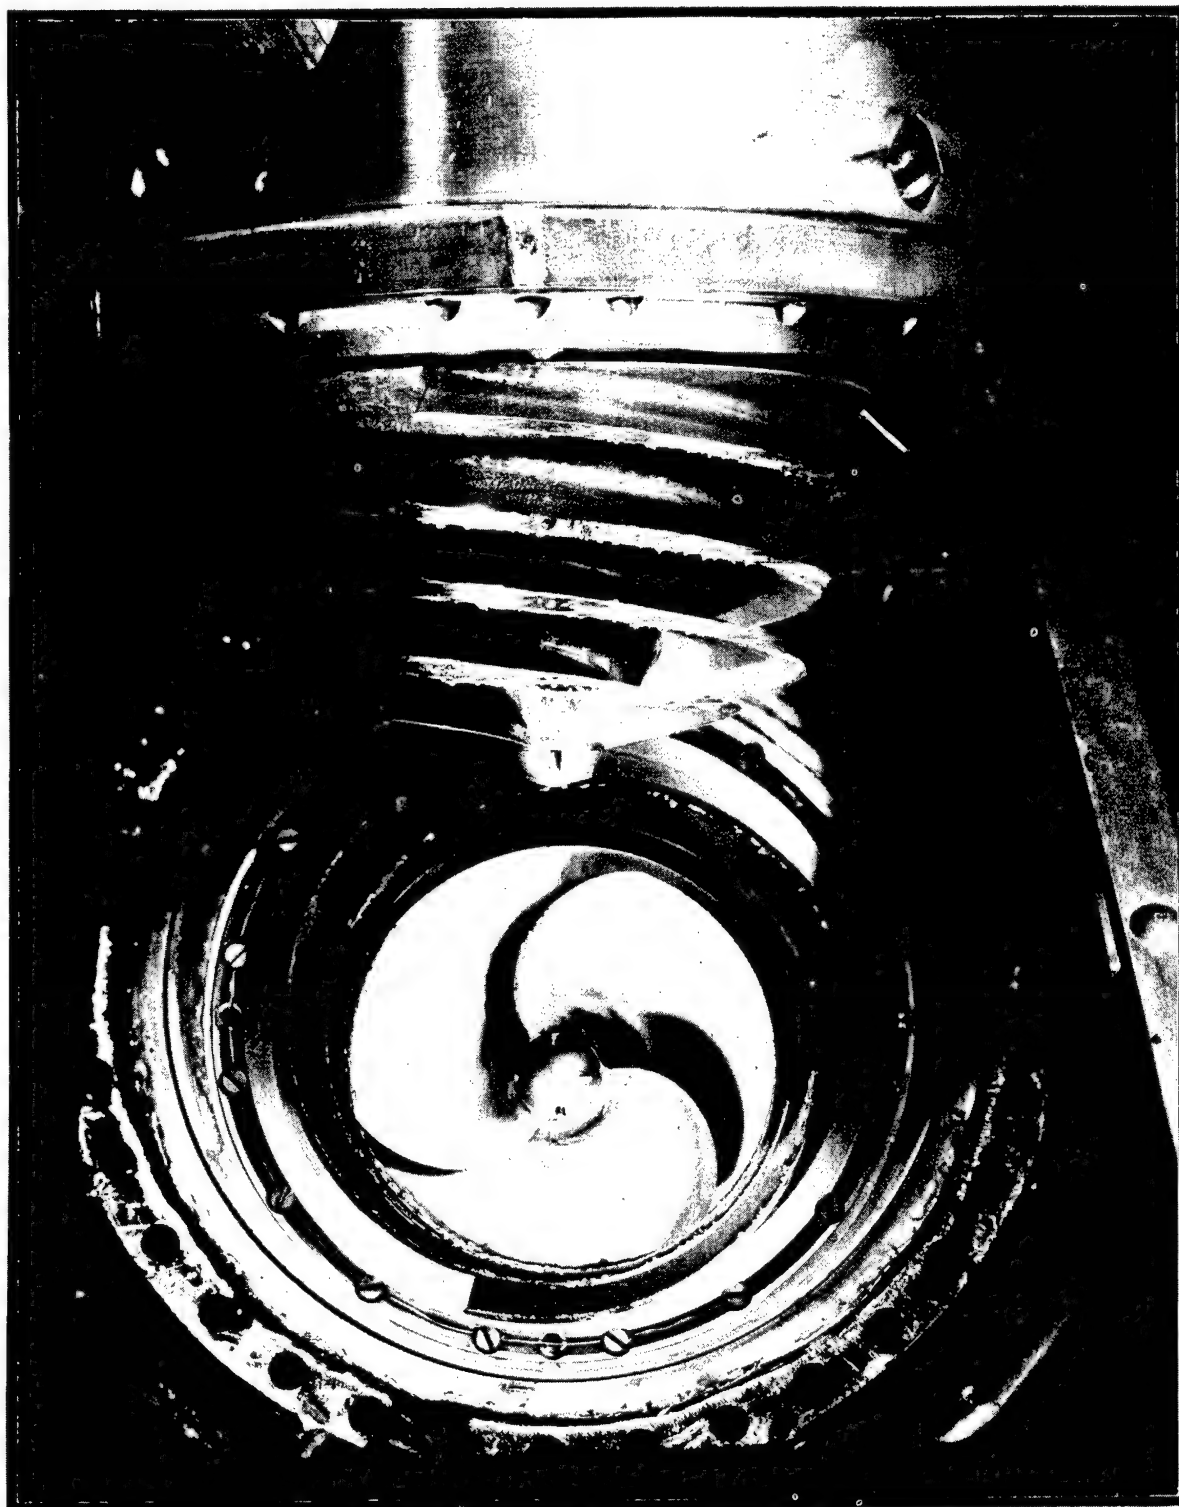
FIG 49

When the turbopump was removed from the test loop, it was immediately apparent that the cause of increased vibration was rubbing contact between the impeller and scroll insert. A photograph of the impeller shortly after removal from the scroll is shown in Fig. 49. Two views of the impeller were obtained in this figure by placing a mirror at an angle under the pump. Several areas of cavitation damage were also noted, one of which can be seen in Fig. 49.

IMPELLER DAMAGE AS SEEN AFTER LIQUID METAL TEST

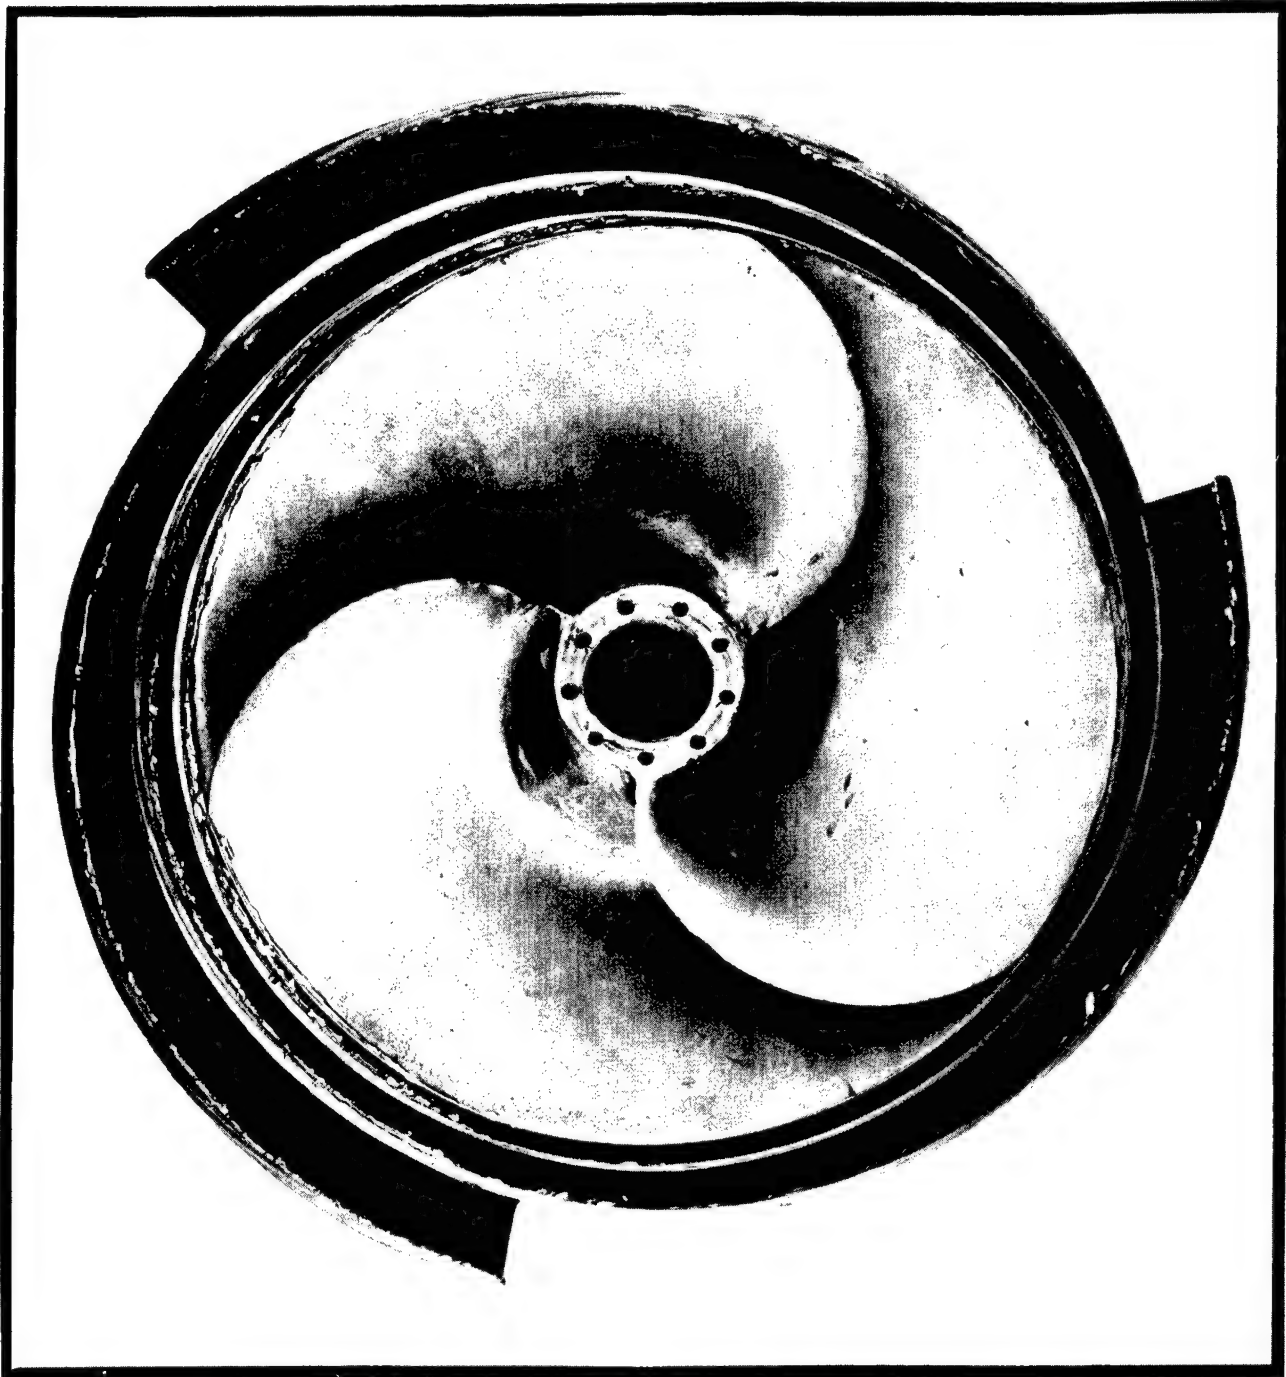
FIG 50

Complete disassembly of the pump revealed additional rubbing damage of the rotating parts. The damage on the impeller is shown more clearly in Fig. 50. It should be noted that the damage is not uniform around the impeller. Very little material was injected into the fluid stream, as evidenced by the apparent flow of metal at the blade tips. Scroll damage from contacting the impeller is shown in Fig. 51. Again, the unsymmetrical pattern of damage should be noted. The cause of the rubbing contact cannot be fully determined from the evidence uncovered, due to the difficulty of separating cause and effect relationships of the damage. However, the unsymmetrical pattern of damage leads to a tentative conclusion that the shaft moved to one side during operation. This is further confirmed by the rubbing damage noted on the dynamic seals shown in Figs. 52 and 53. The cause of this apparent shaft movement has not been satisfactorily determined.

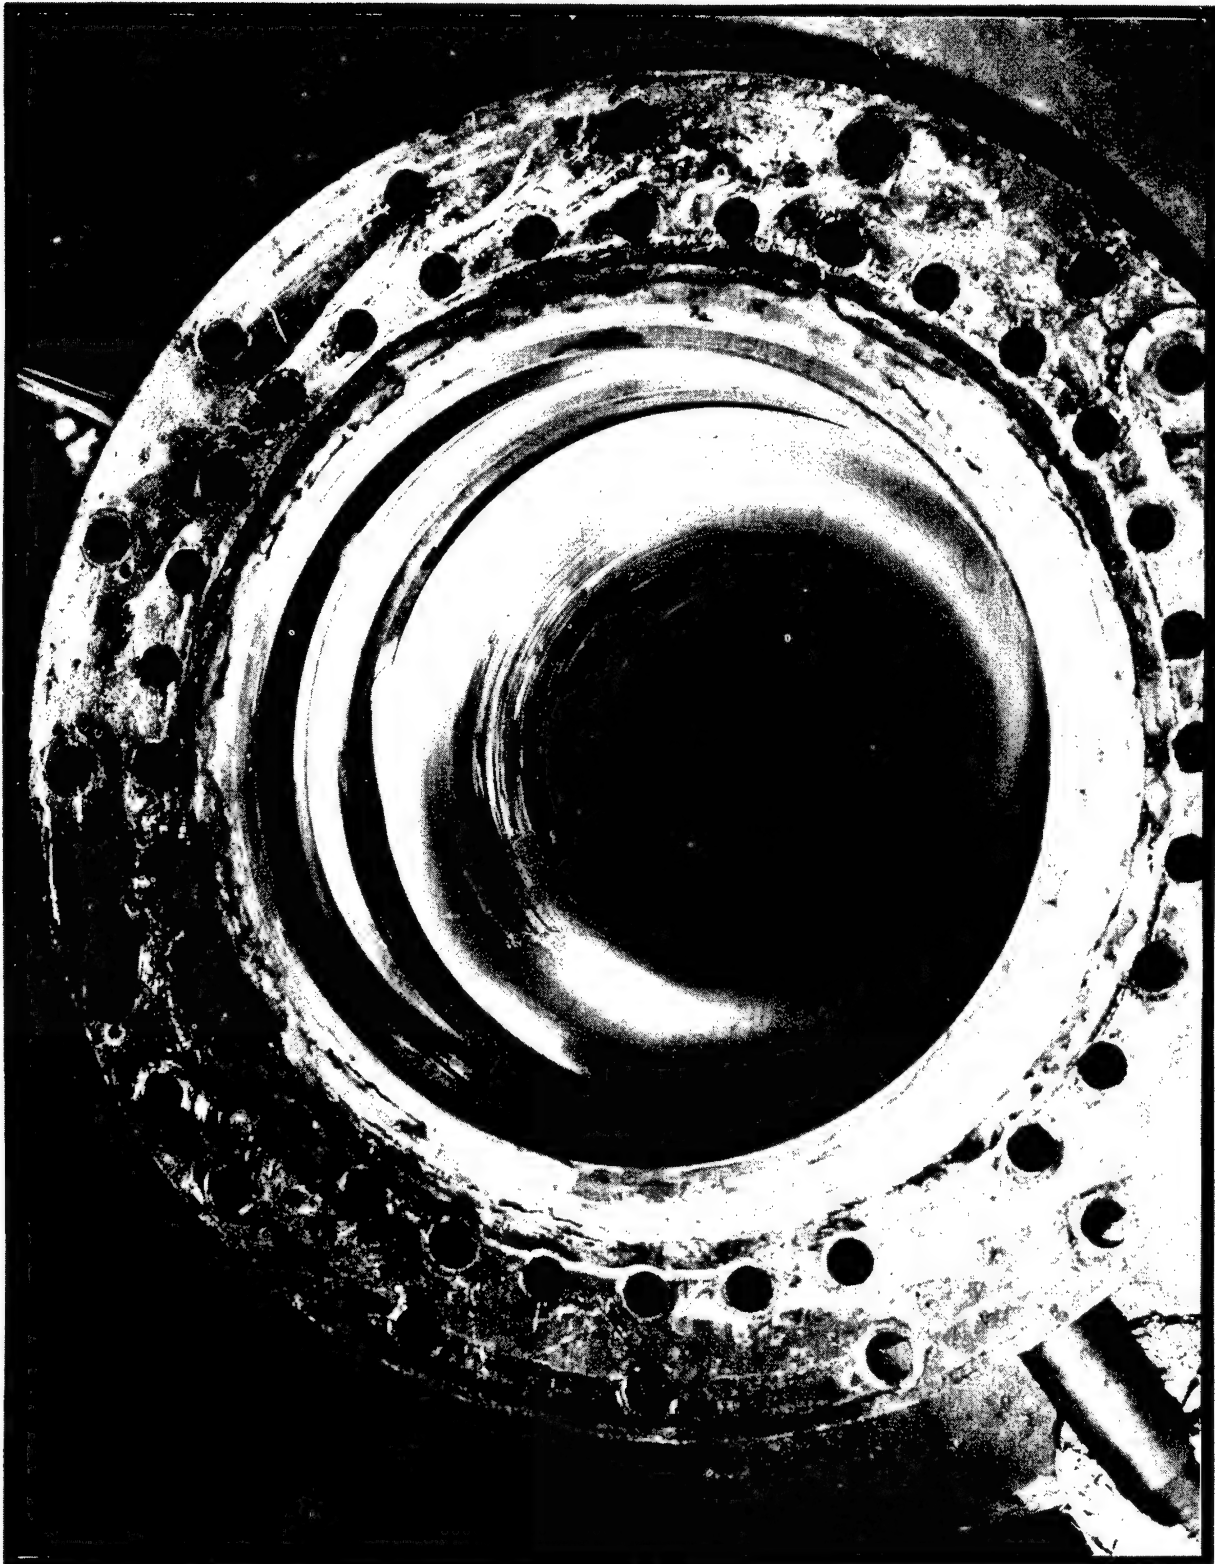
FIG 51

RUB MARKS ON SCROLL ADAPTER

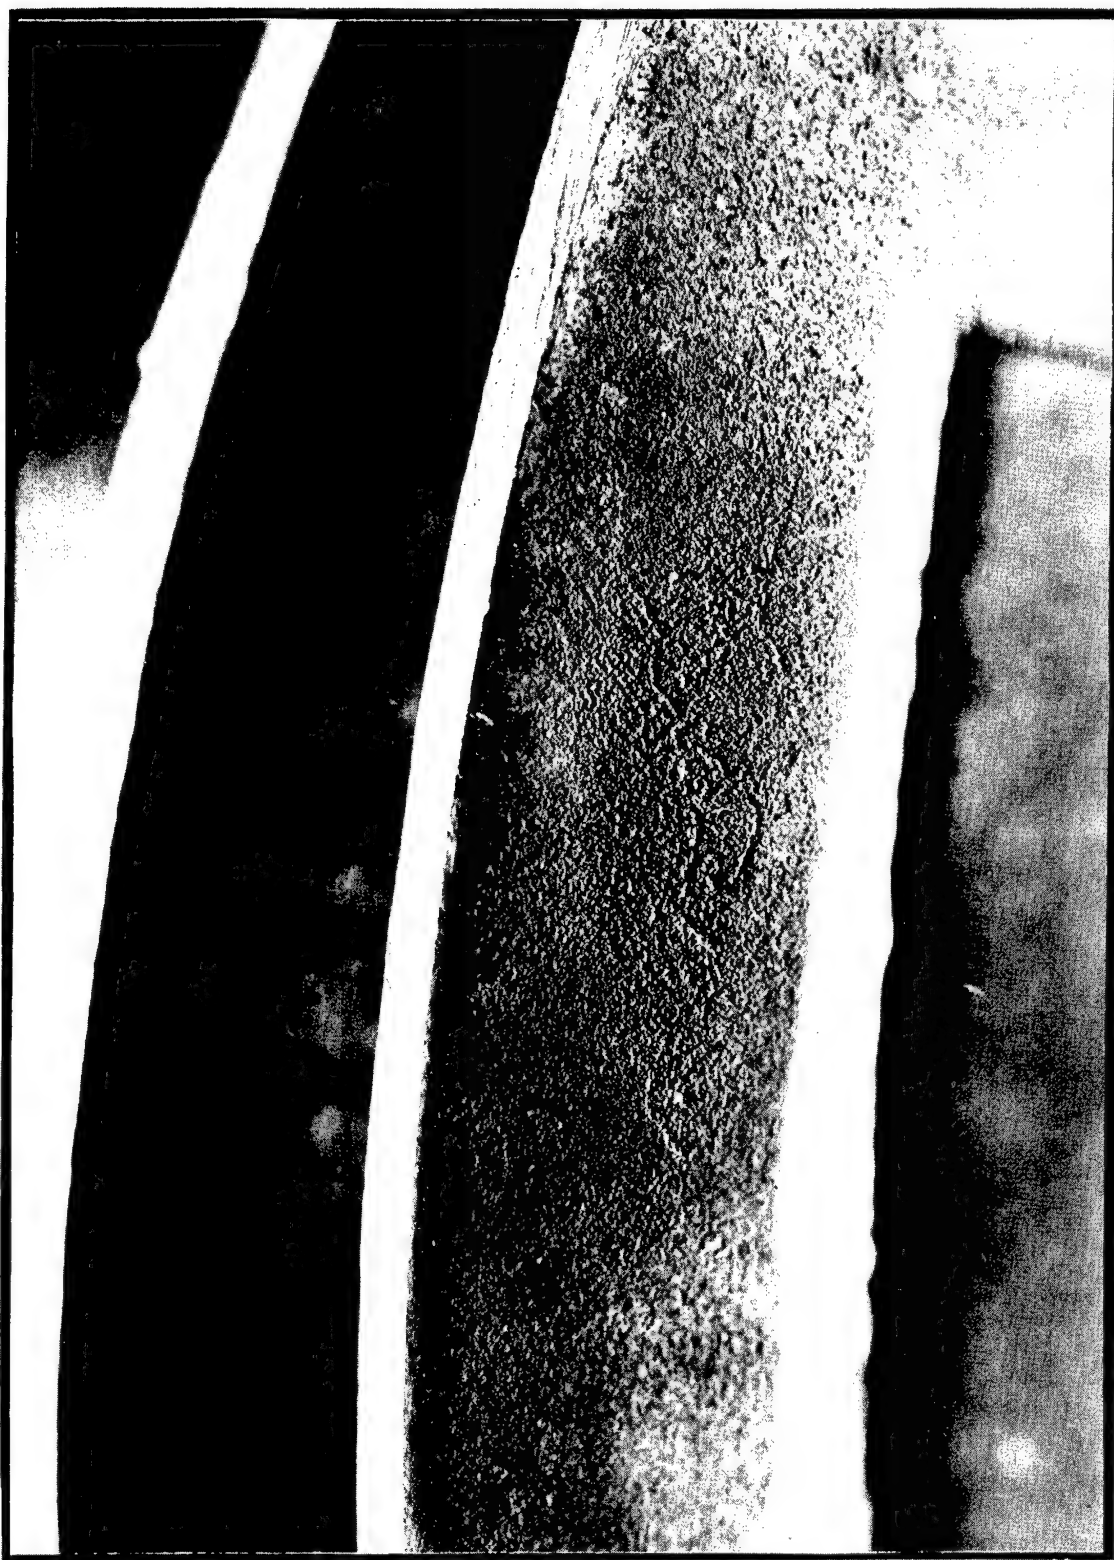
FIG 54

The principal areas of cavitation damage were located on the pressure surfaces of the vanes in the rear channels. These areas are shown in Figs. 54, 55, and 56. An area of secondarily induced cavitation damage was found on the suction surface of vane 2 and is shown in Fig. 57.

CAVITATION DAMAGE ON VANE 2

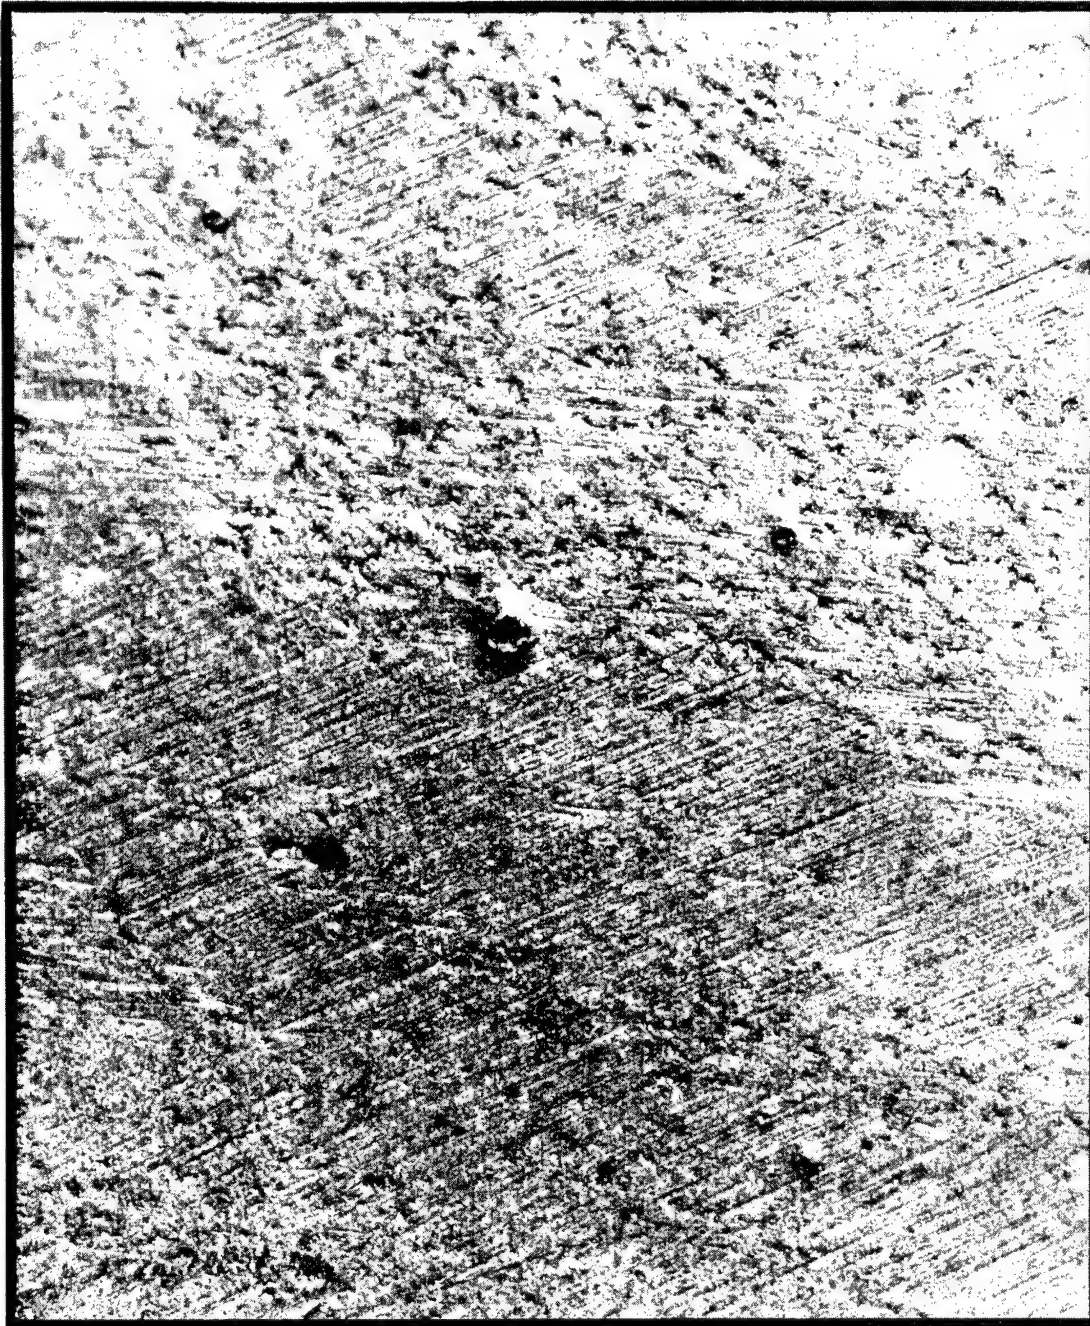
FIG 65

SINGLE EVENT PITTING OF VANE 3 PRESSURE SIDE

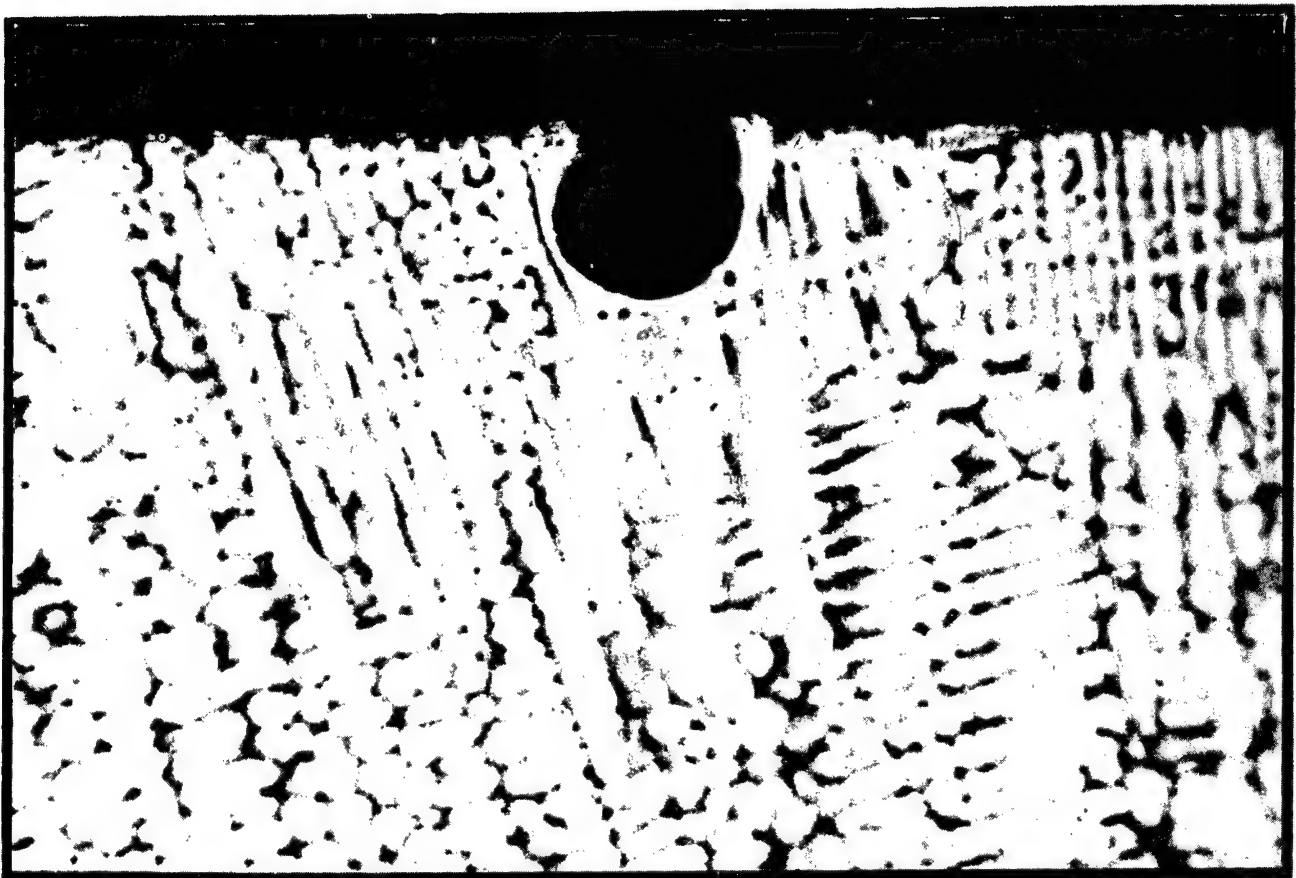
FIG 66

LARGE PIT OF FIG. 65 IN CROSS SECTION

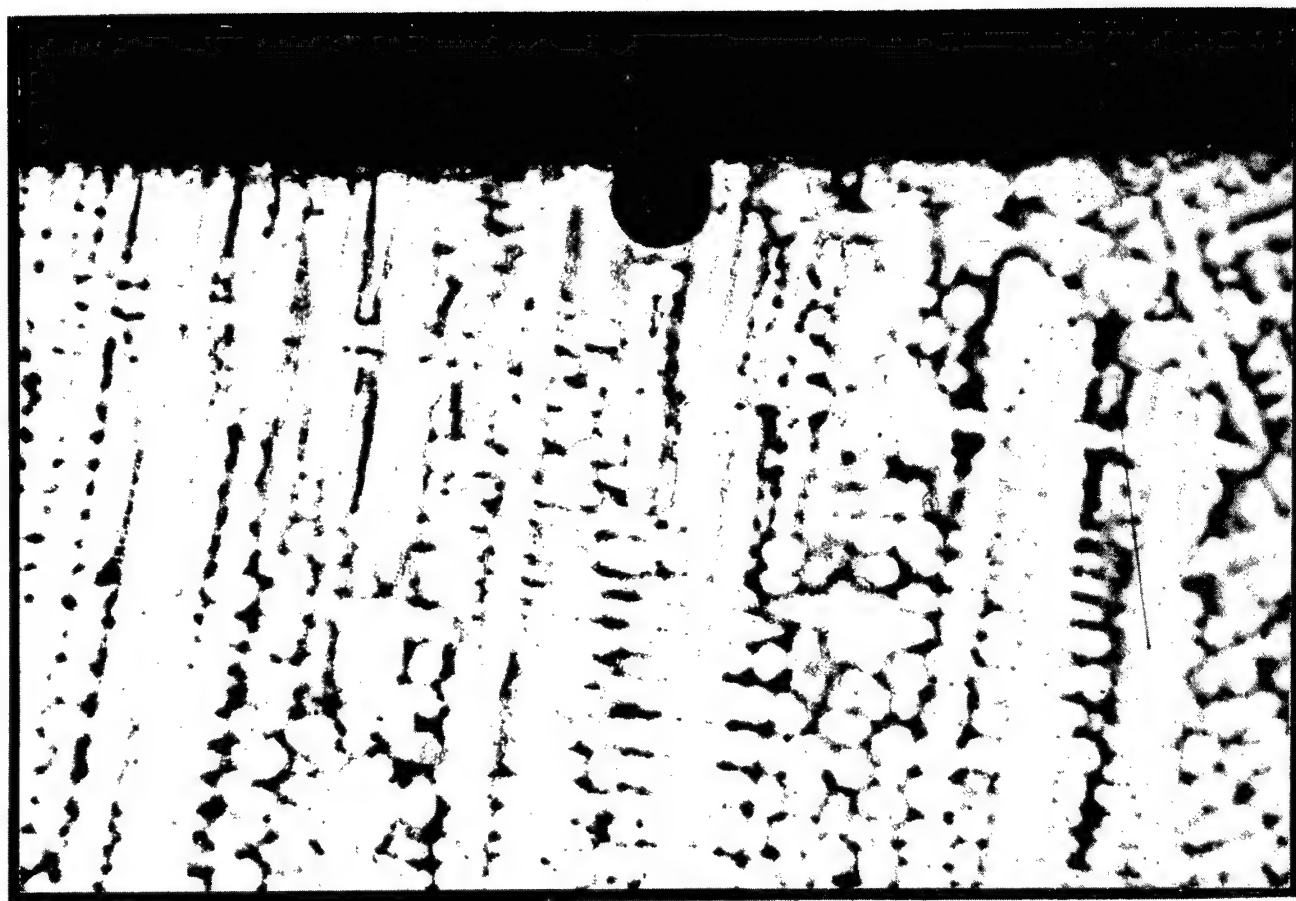
FIG 67

SMALLER PIT OF FIG. 65 IN CROSS SECTION

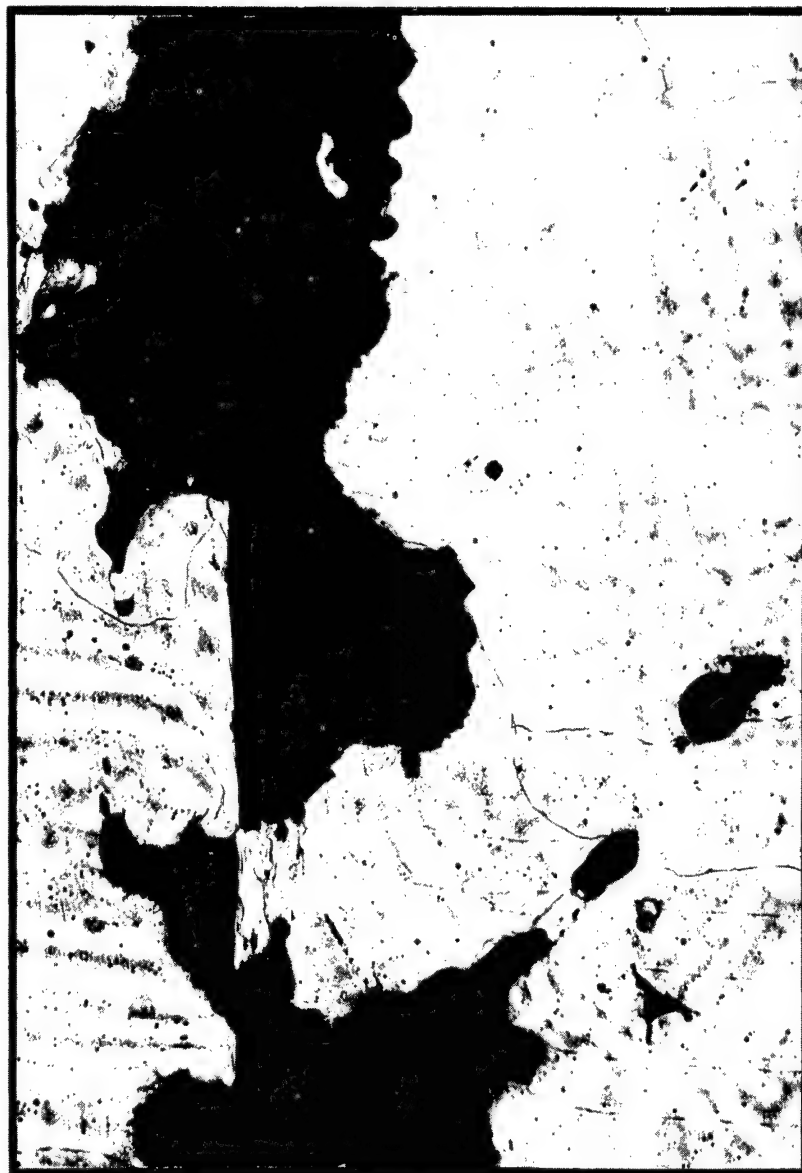
FIG 71

# PHOTOMICROGRAPH OF VANE 2 CAVITATION DAMAGE

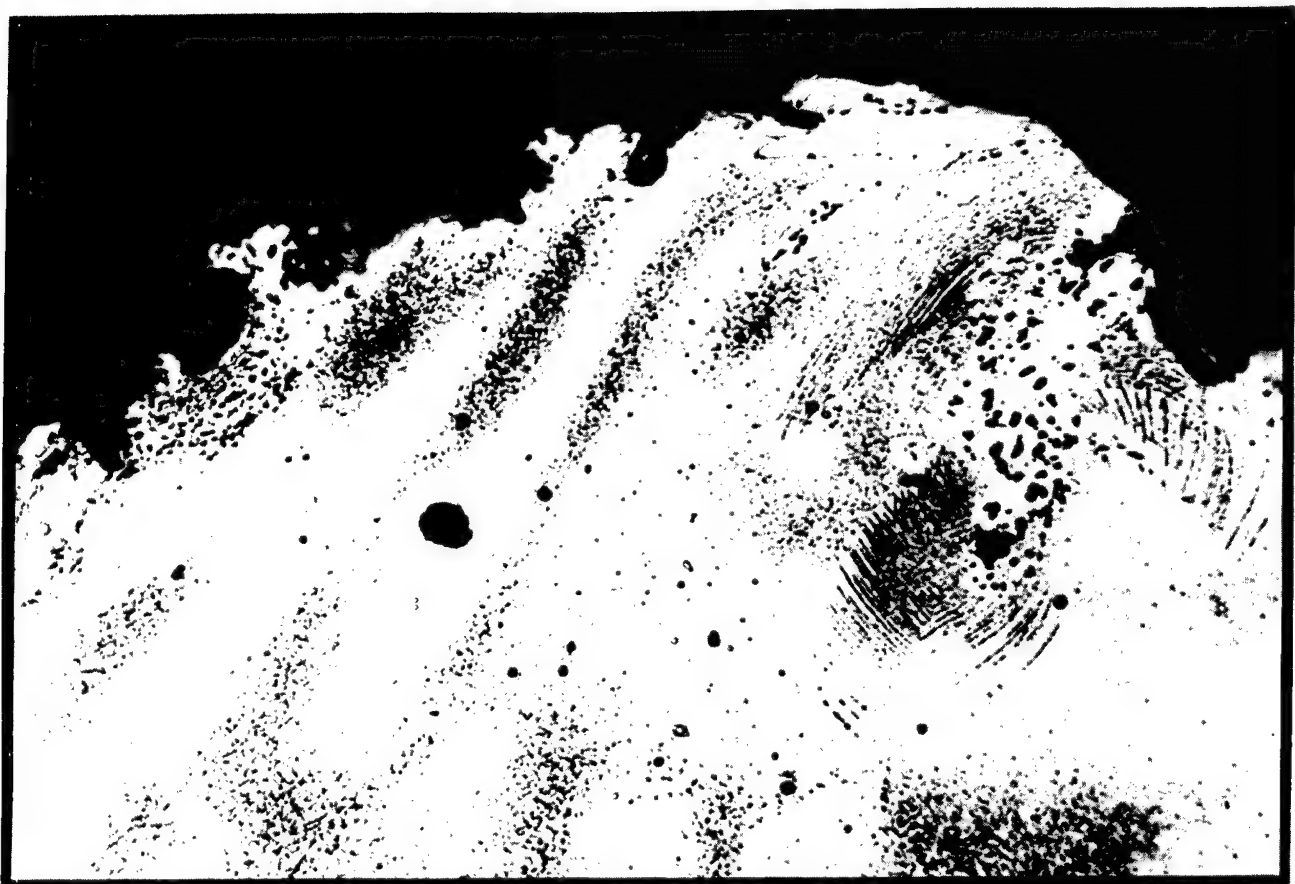
FIG 72

PHOTOMICROGRAPH OF VANE 2 CAVITATION DAMAGE AT  
500X

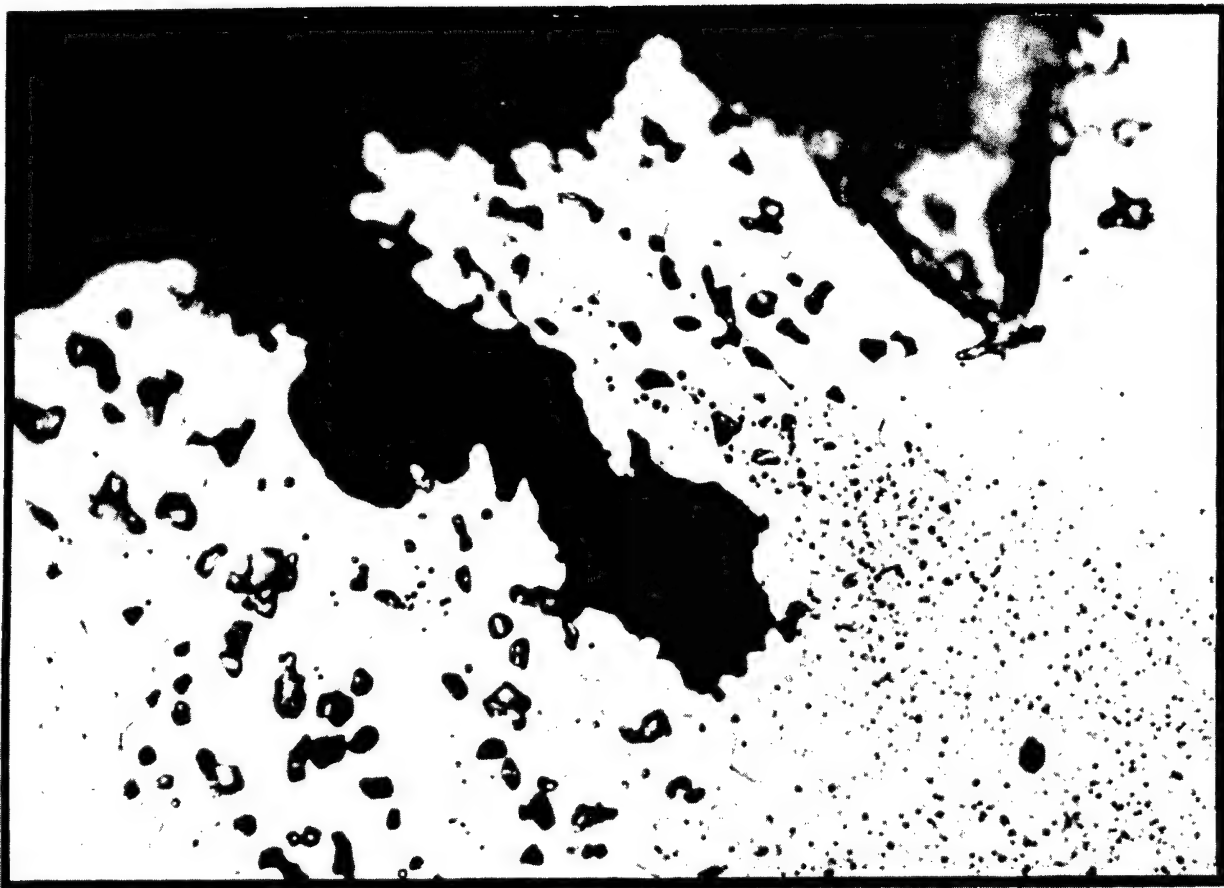
FIG 73

PHOTOMICROGRAPH OF VANE 2 CAVITATION DAMAGE  
AT 2000X

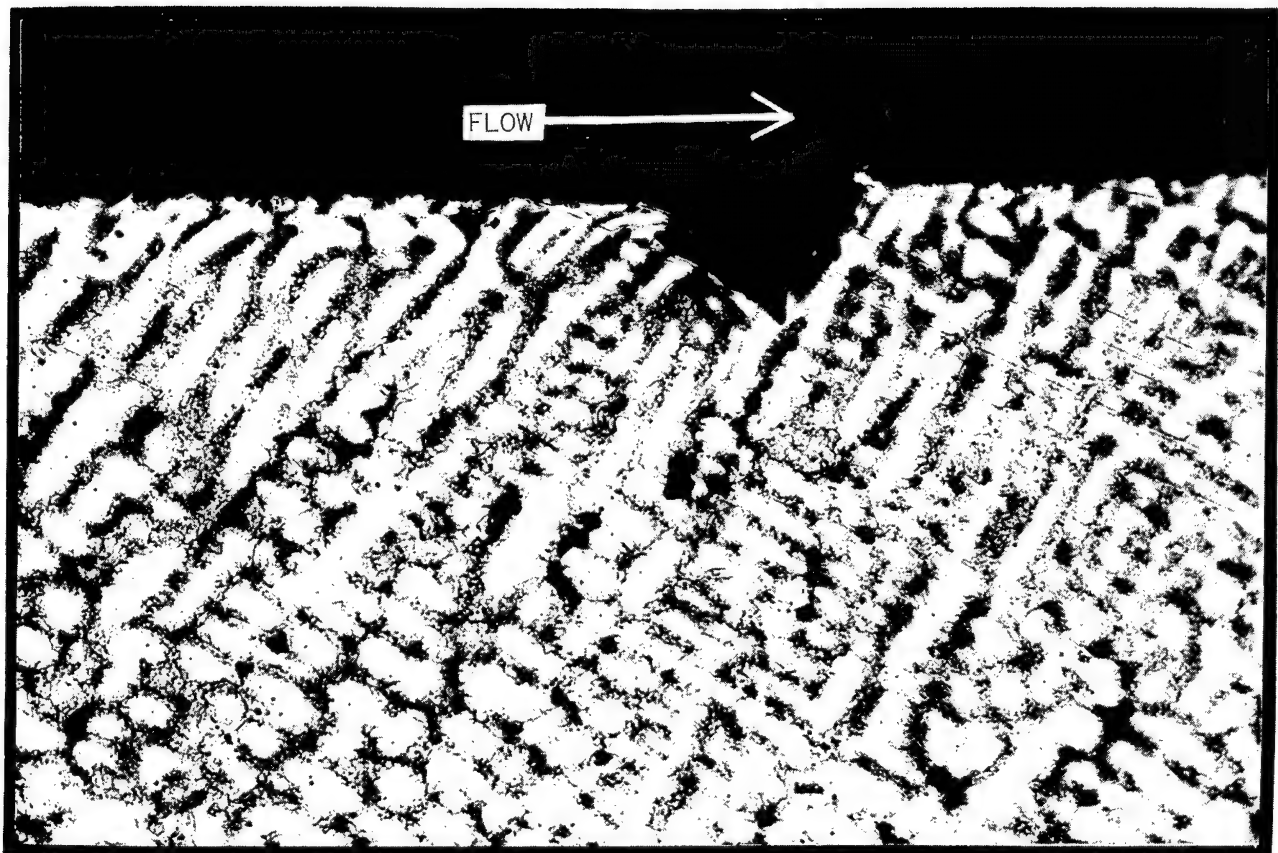
FIG 74

PHOTOMICROGRAPH OF PROJECTION CAUSING CAVITATION DAMAGE
